# Manhole Inspection Summary

Manhole # S15E\_\_011MH

Insp Date: **5/26/09 3:16 PM**

**Location** Address: **2800 W SARATOGA ST**

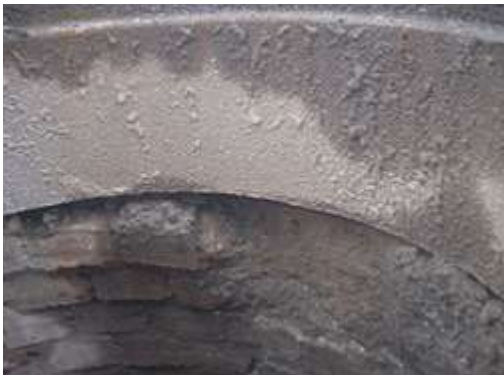
Defect 1

Condition: ☐ Sound ☐ Cracked ☐ Root Intrusion ☐ Loose Brick ☒ **Deteriorated**

Infiltration: ☐ None ☒ **Joint** ☐ Cracks ☐ Mortar ☐ Roots ☐ Wall

DETERIORATED CORBEL WITH JOINT INFILTRATION

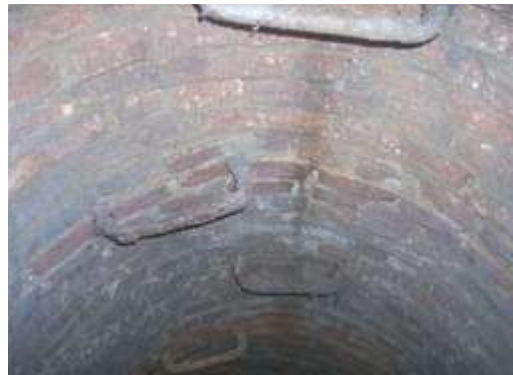
Defect 2

Count: **5** Missing: **0** ☒ **Corroded**

☒ **Evidence Of Surcharge** Depth: **2** (ft.) ☐ Active Surcharge Present

CORRODED STEPS AND Evidence of ASUR

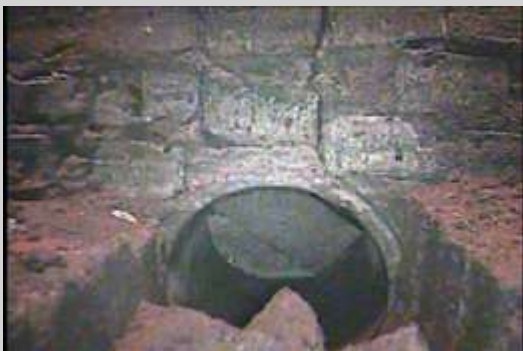
6 O'Clock Inflow

ABANDONED PIPE

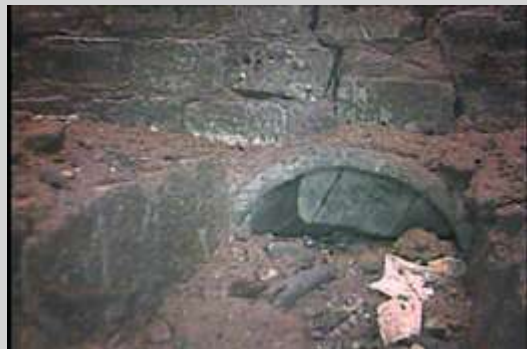
9 O'Clock Inflow

ABANDONED PIPE
